BEACH WATER QUALITY REPORT

FOR NELSON MANDELA BAY METRO MUNICIPALITY

GQEBERHA (PORT ELIZABETH)

By: ASC Public Health | Food Safety
21 September 2023 – 15 November 2023

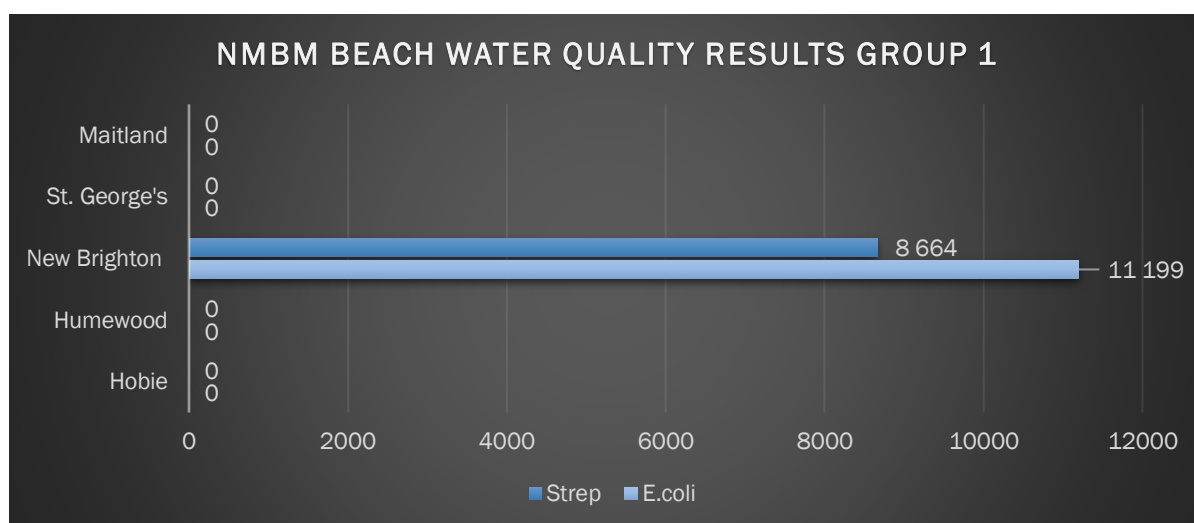
Graph 1: Beach Water Quality results from ASC 21 September 2023

The findings of the study revealed that four out of the five examined beaches exhibited outstanding water quality, with no detected presence of pathogenic faecal indicators. These beaches demonstrated exceptional cleanliness and hygiene within their surroundings. Specifically, Hobie (Summerstrand) beach and Humewood beach, both holding Blue Flag status, demonstrated pristine water quality without any faecal indicators. These beaches, located in the tourist-rich area within the NMBM, provide an excellent bathing experience for visitors, indicating no immediate health risks.

Beach Water Quality Results - 21 September 2023

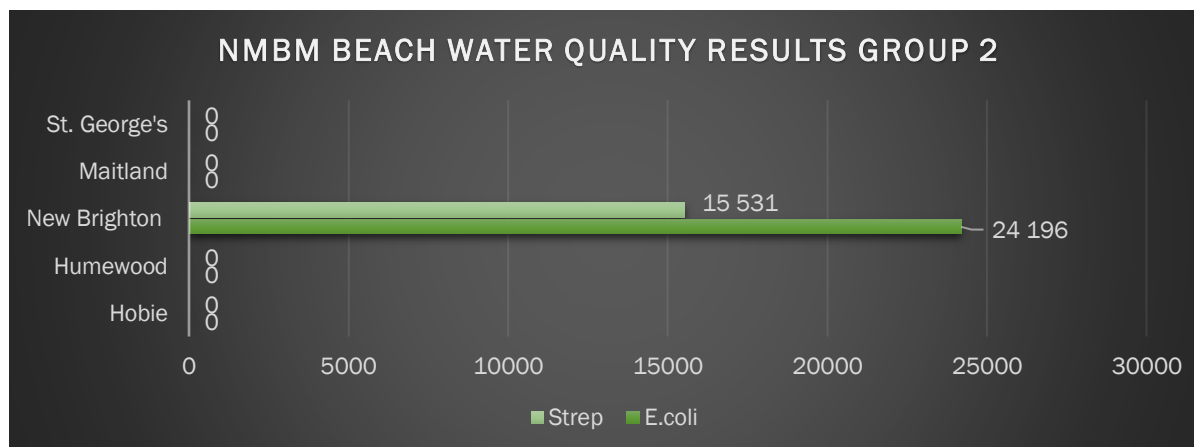
Graph 1: Beach Water Quality results from ASC 21 September 2023

Beach Water Quality Results – 15 November 2023

Regrettably, New Brighton Beach exhibited significant faecal contamination beyond the standards used in this study. The *E. coli* contamination level was 45 times higher than the Blue Flag standard, while the *Streptococci* contamination level was 87 times higher. The surrounding conditions were unsuitable for use, with damaged pathways littered with broken glass bottles. Additionally, offshore oil spillage further contaminated the water, and during the sampling, there was clearly oil residues in water. It is important to note that this beach remains accessible to the public and serves as the only nearby option for residents in disadvantaged communities within the Ibhayi area.

Implement effective water treatment measures to reduce faecal contamination from sewage spills and other sources.

Conduct regular beach cleanup initiatives to maintain cleanliness and remove potential sources of contamination.

Establish a robust monitoring and reporting system to regularly assess beach water quality and promptly inform the public about any potential health hazards.
